COUNTIES (MD/PA) WASHINGTON/FRANKLIN  
M&D milestone no. 107 (111)  
MHT-HSI no. WA-I-488

FIELD SHEET: MASON & DIXON LINE, MARYLAND-PENNSYLVANIA BOUNDARY MARKER SURVEY

MASON & DIXON WEST LINE, MILESTONE 107 (III)

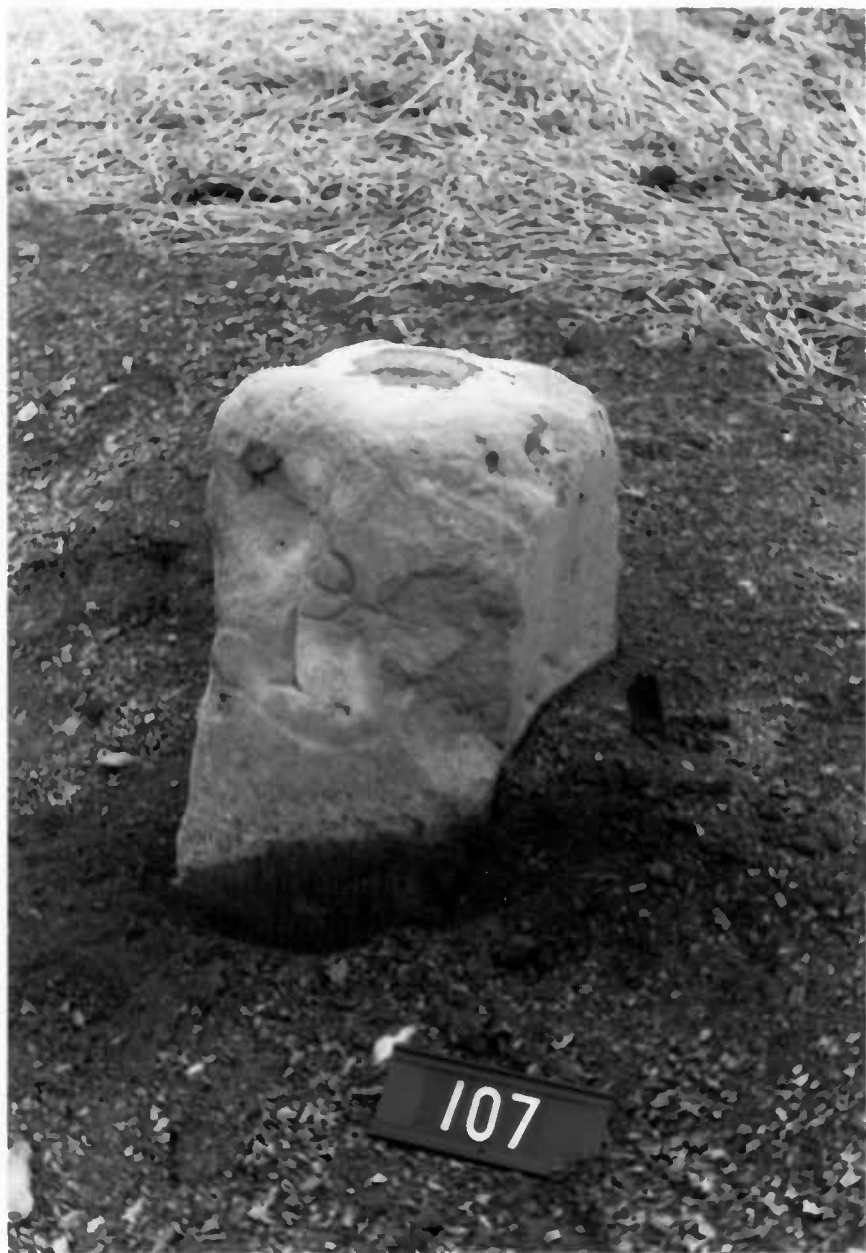
PHOTO: ALICE MARTIN (1981.6.9) 2/28/81

1979-81 Inspection notes: order no. 107(111); photos/negatives/slides no. 107(111)  
107 (111). Original M&D milestone of 1767 probably in place, though out of plumb  
(leaning to S); in fair condition; may not be firmly set. Letters and all  
surfaces disfigured by large chips and weathering; top, by setting of USC&GS  
Reference Mark No. 2 disk (1939). Endangered by farm machinery.

NW CORNER (P/-)

If this stone is to be saved: MGS will want to contact the surrounding property owner and tenant farmer as soon as possible, to make arrangements for better protection from farm machinery damage. MGS will also want to find out whether stone is broken off below grade, for it's now out of plumb. A tall post, tall enough to be seen above the corn crop may be all that's necessary. The Poe family was very hospitable and helpful, and would be glad to cooperate, I'm sure. We did not attempt to locate the other USC&GS Reference Marks in the vicinity.

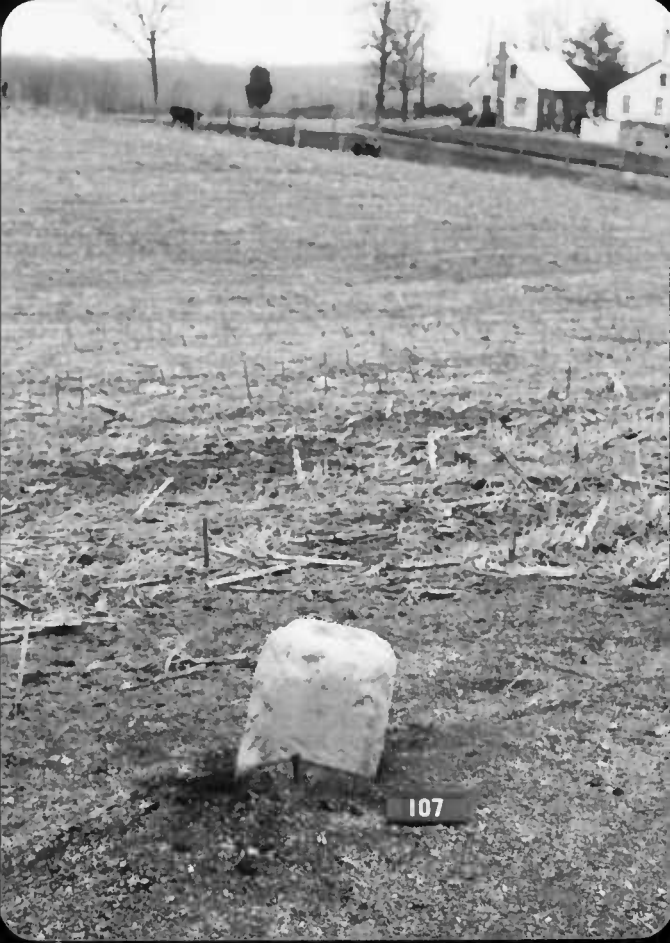
PHOTO: ALICE MARTIN (1981.6.11)  
2/28/81

← WAS LOOKING E TOWARD  
STONE & JUNCTION OF  
WISHARD RD WITH MD 58  
(CEARFOSS RD) - at top of photo

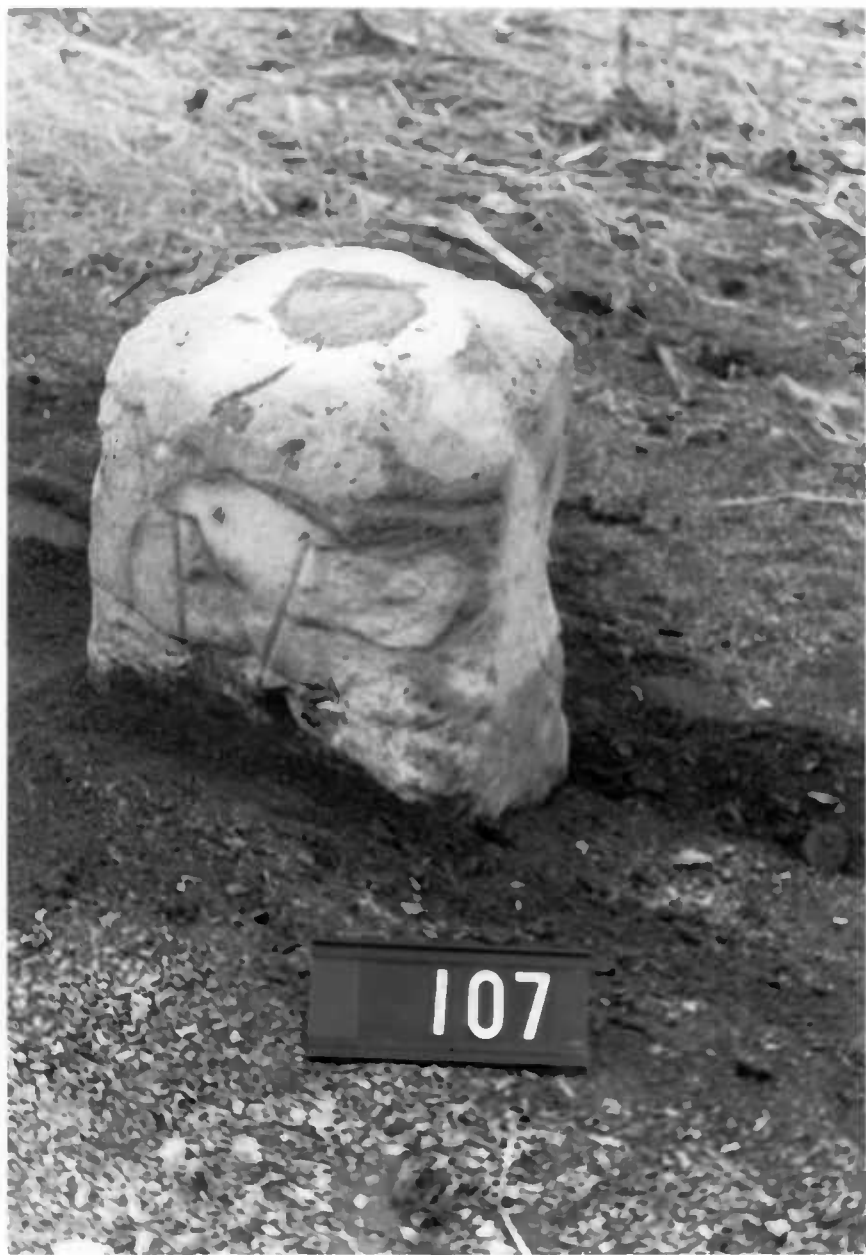
PHOTO: ALICE MARTIN (1981.6.12) 3/25/81

SE CORNER (M1-)
